**EXHIBIT A**  
**Scope of Work**  
**PORT OF CHELAN COUNTY**  
**Olds Station – IB No. 9 Awning Repair**

**FIGURE 1- IB NO. 9 AWNING  
REPAIR OVERVIEW**

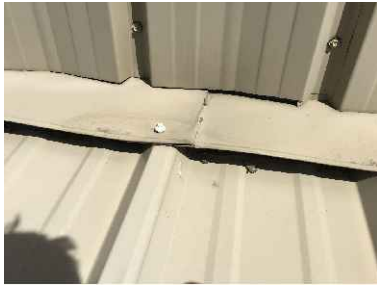
**MISC. SEAM**

- Deterioration of sealant and foam closures on the upslope side of the awning;
- Failing sealant at miscellaneous flashing seams; and
- Failing sealant at gutter seams.

Repair Misc. Seam Sealant

The unit price shall cover the complete cost of providing all materials, equipment, and labor necessary to remove and replace sealant at various seams between the metal roofing components. The price includes, but is not limited to: removing all old sealant; cleaning the roof for proper application of the new sealant; installing sealed fasteners at all seams; applying new sealant at the seams; and cleaning up the worksite. Assume four (4) fasteners will be installed per linear foot (lf) of seam. The work to repair the sealant will be paid for per linear foot.

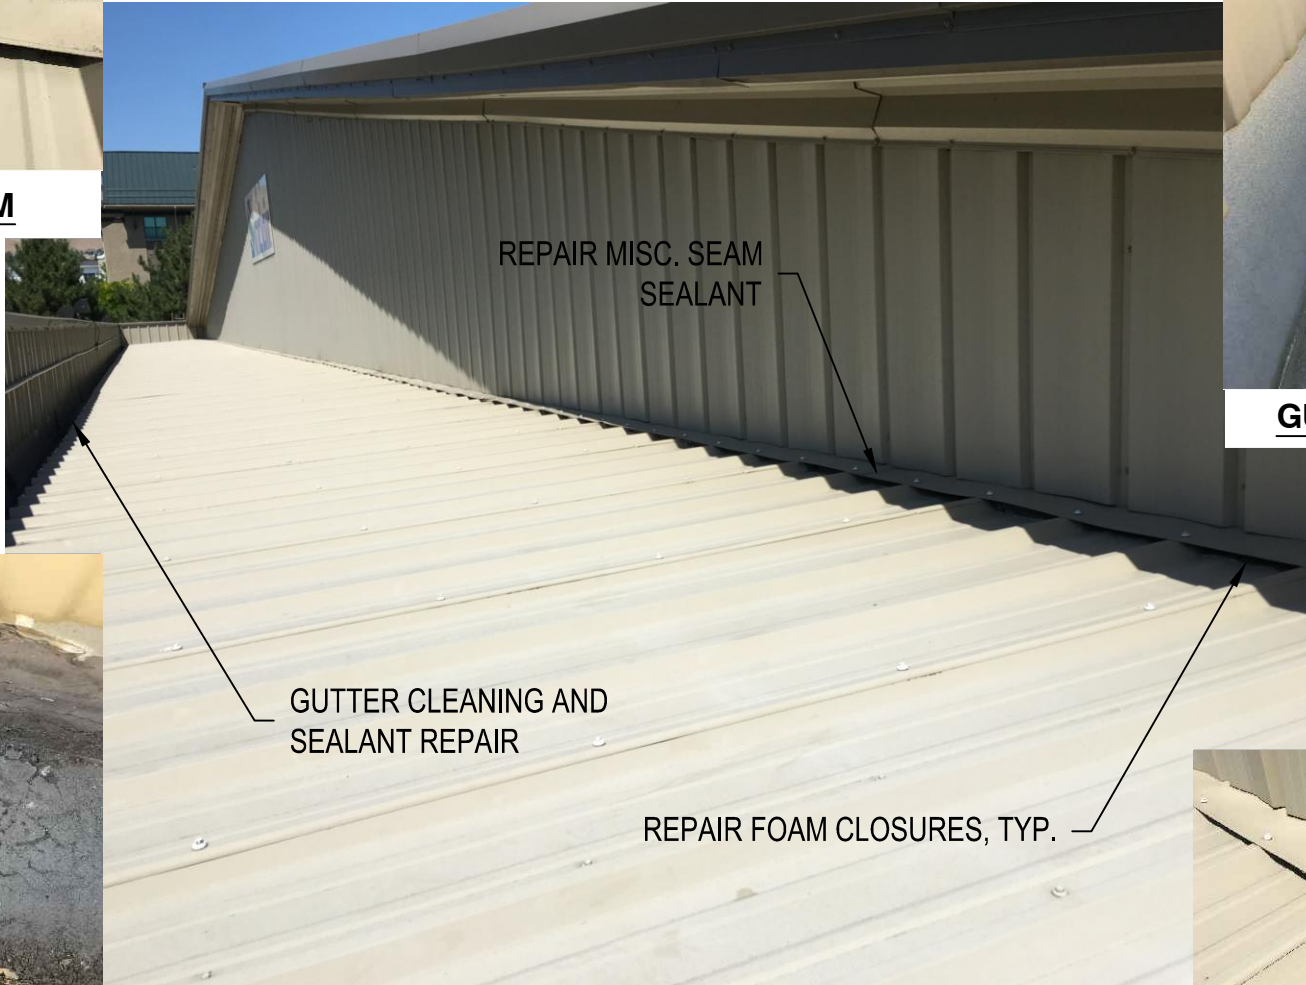
**AWNING OVERVIEW**

The awning located on the west side of Industrial Building No. 9 located at 2605 Chester Kimm Road in the Olds Station Business Park needs minor repair work to address multiple locations where water is entering the awning interior envelope and causing leaks on the underside of the awning. An inspection of the awning's roofing system has been performed and the following items have been identified as primary contributors to the leaking:

REPAIR MISC. SEAM  
SEALANT

GUTTER CLEANING AND  
SEALANT REPAIR

REPAIR FOAM CLOSURES, TYP.
